Home Report

11 Seaview Terrace Fort William PH33 6RG

Prepared by:
Samuel & Partners
First Surveyors Scotland
First Floor, 20 High Street
FORT WILLIAM
PH33 6AT

1. Property Questionnaire
2. Single Survey
3. Mortgage Valuation
4. Energy Report

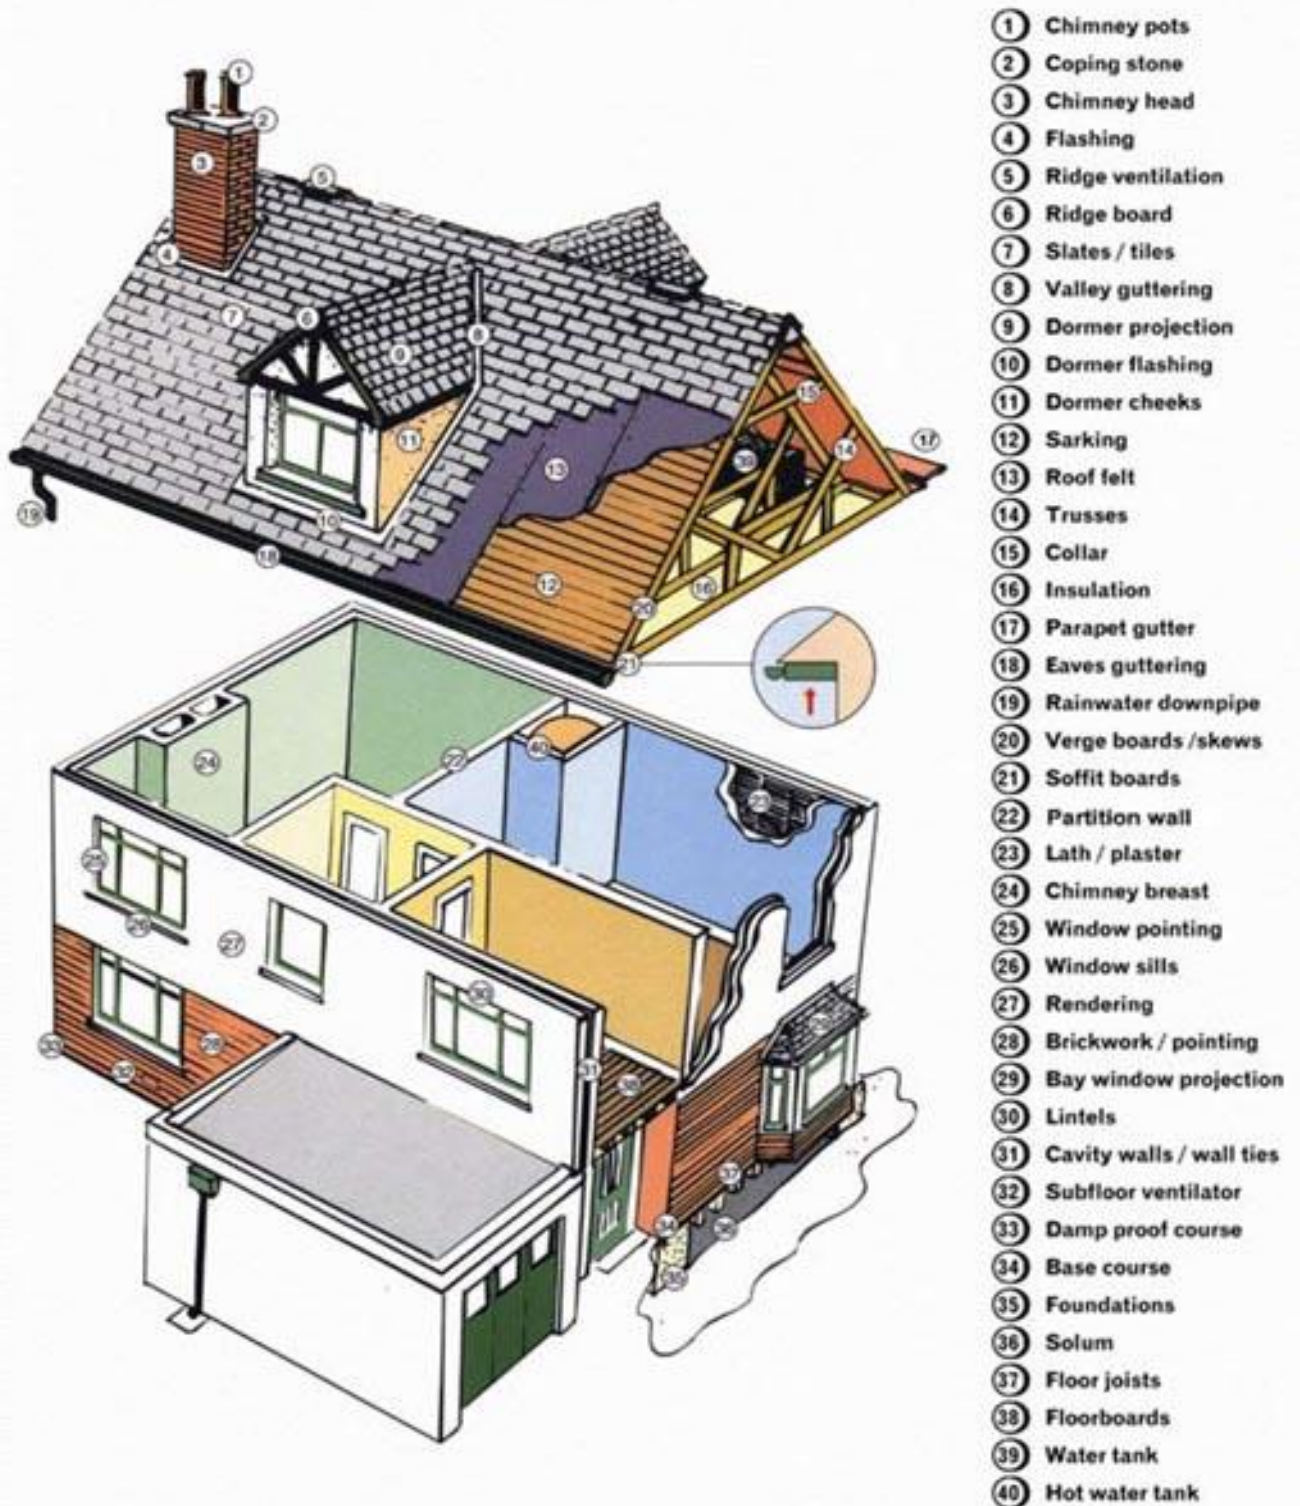
Sectional Diagram showing elements of a typical house

Reference may be made in this report to some or all of the above component parts of the property. This diagram may assist you in locating and understanding these items.

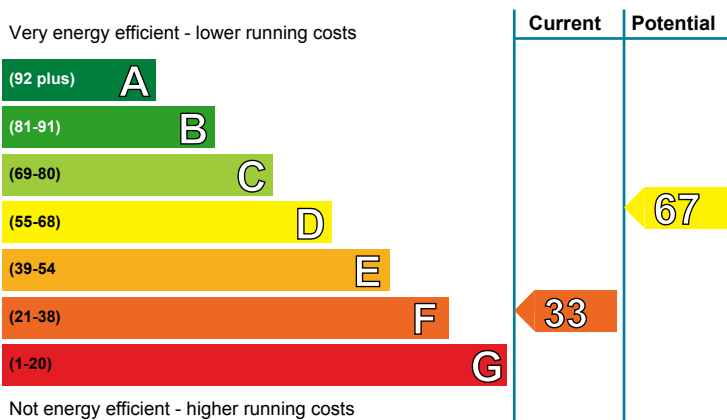
Energy Efficiency Rating

This graph shows the current efficiency of your home, taking into account both energy efficiency and fuel costs. The higher this rating, the lower your fuel bills are likely to be.

Your current rating is **band F (33)**. The average rating for EPCs in Scotland is **band D (61)**.

The potential rating shows the effect of undertaking all of the improvement measures listed within your recommendations report.

Estimated energy costs for your home for 3 years*	£7,068	See your recommendations report for more information
Over 3 years you could save*	£3,705

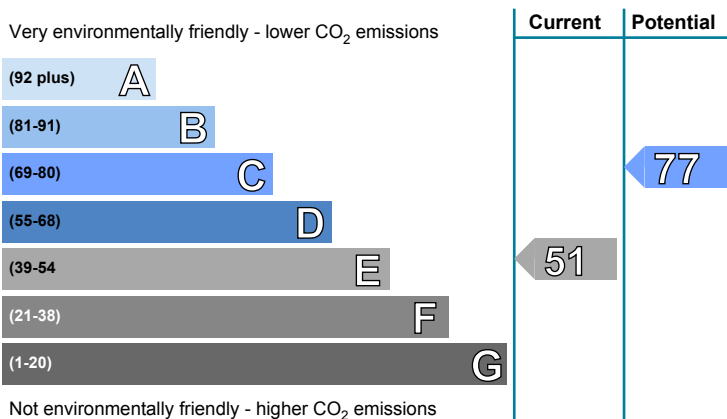
Environmental Impact (CO₂) Rating

This graph shows the effect of your home on the environment in terms of carbon dioxide (CO₂) emissions. The higher the rating, the less impact it has on the environment.
