**5 Glasdrum Court
Glasdrum Road
Fort William
PH33 6QR**

Inspected On: 10th December 2024

Prepared by:
Samuel & Partners
First Surveyors Scotland
First Floor, 20 High Street
FORT WILLIAM
PH33 6AT

Home Report Index

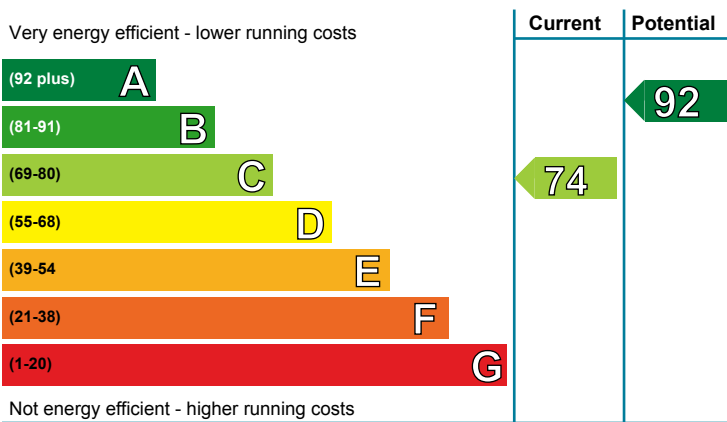
Energy Efficiency Rating

This graph shows the current efficiency of your home, taking into account both energy efficiency and fuel costs. The higher this rating, the lower your fuel bills are likely to be.

Your current rating is **band C (74)**. The average rating for EPCs in Scotland is **band D (61)**.

The potential rating shows the effect of undertaking all of the improvement measures listed within your recommendations report.
